THE IMPACT AND THE RISK OF ABANDONED BUILDINGS FROM PETROȘANI CITY ON THE URBAN ENVIRONMENT

Description of the studied abandoned buildings

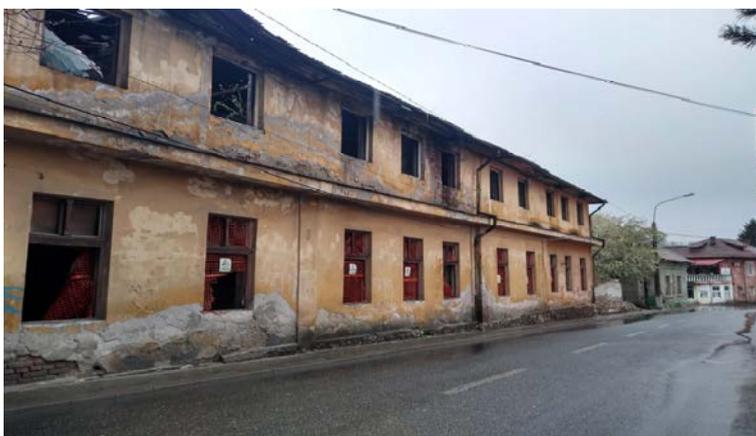
B1. Former Military Unit 01032 (private property, area 1) - constructed in the central area, is ruined on the day that passes, without the authorities being able to intervene (figure 3).

Fig. 3. *Former Military Unit 01032*

It should be noted that in addition to the danger it poses for passers-by, periodically pieces of plaster, bricks and tiles falling from the building, there is also the danger of arson and its propagation in the neighboring buildings. In fact, in the last 5 years, firefighters were forced to intervene 4 times in order to extinguish fires caused by those who sheltered in these ruins and tried to warm themselves.

For this reason, part of the abandoned buildings (B1, B3 and B4) must be removed from the urban landscape/environment of Petrosani city (demolished, and the land thus released made available for other purposes), and another part must enter as soon as possible in capital repairs and rehabilitation works.

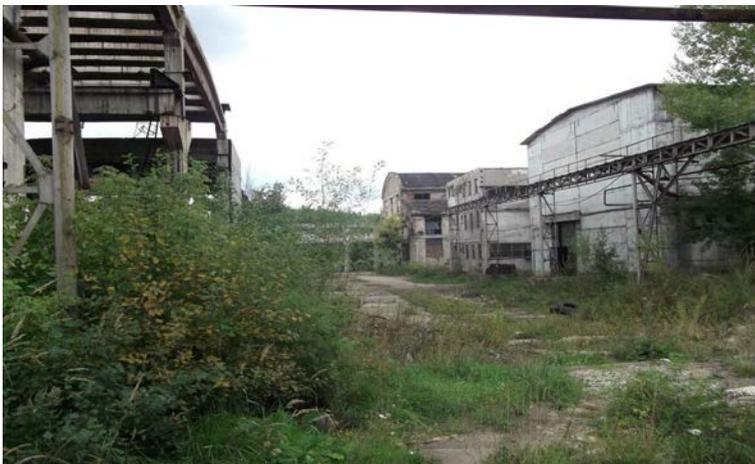
B2. Petroșani Central Workshops/IUMP/UMIROM/GEROM (private property, area 3) - at the north entrance in the city of Petroșani, between Dărănești and Petroșani Rail Station, we are greeted by the ruins of what was once an important mining equipment company in Romania.

Today, with the exception of the building located at gate 1, which functions as an event hall, from the former company a few workshops still operate (whose days are counted), the rest being practically abandoned (figure 4). And in this case we are also talking about a private property about which we weren't able to obtain much information.

Fig. 4. *Petroșani Central Workshops*

This industrial objective could easily be rethought and integrated into the local and national economy. Even if there is no demand for mining machinery, equipment and subassemblies, a wide range of products for other industries and for general use could be produced here.

Some of the old buildings could easily have been passed in the Industrial Heritage of Romania together with some of the equipments (on the model of the former buildings of Petrila mine) and could have gained a later destination (even introduced in a wider industrial tourist circuit, developed throughout the entire Jiu Valley).

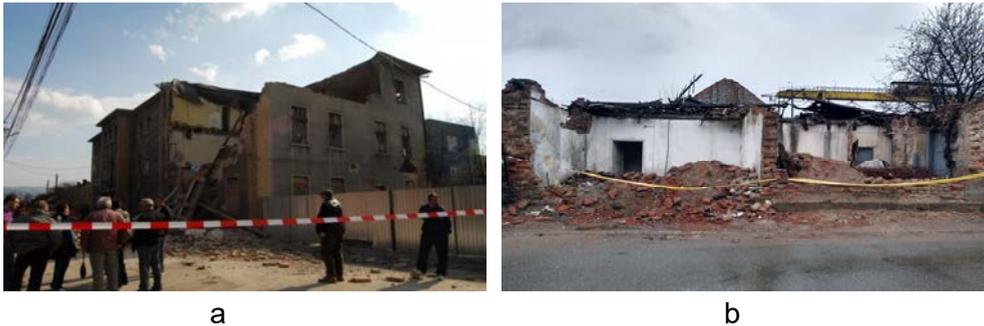
Fig. 5. CONSMIN buildings on Mihai Eminescu street (a) and Cărbunelui street (b)

Two of the buildings (located on Mihai Eminescu and Cărbunelui streets) were abandoned, at present being in a state of ruin and constituting a real public danger for passers-by (by collapsing of constructive elements) (figures 5.a and 5.b).

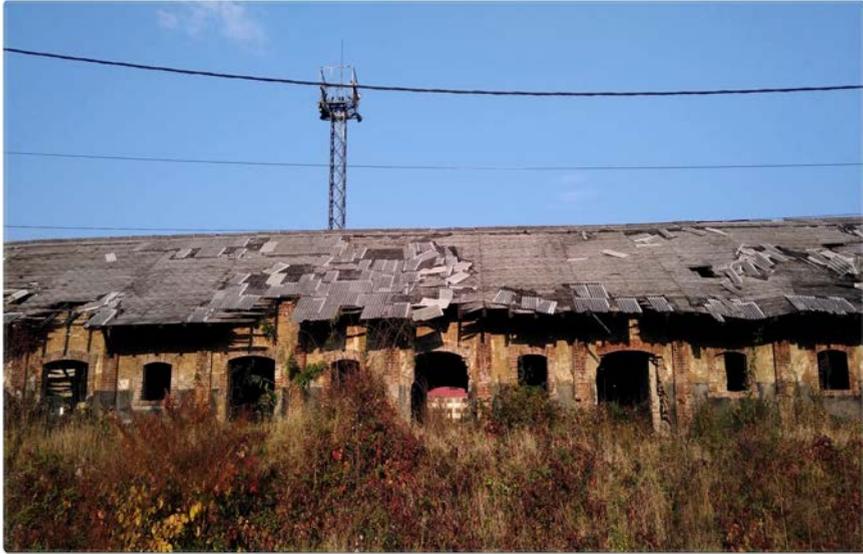
B5. CFR (Romanian Rail Ways) Deposits (CFR patrimony, area 3) - located at the north exit from Petrosani Rail Station, on the left side on the direction towards Simeria, these deposits have not been used since the early 90s (figure 6).

Fig. 6. *CFR deposits*

For a long time in these buildings, the needy people in the Colony District found their shelter turning them into real outbreaks of infection and causing some small fires.

At present the structure of resistance is severely affected, the roof presenting an imminent danger of collapse, was abandoned by people, being "taken over" by homeless animals.

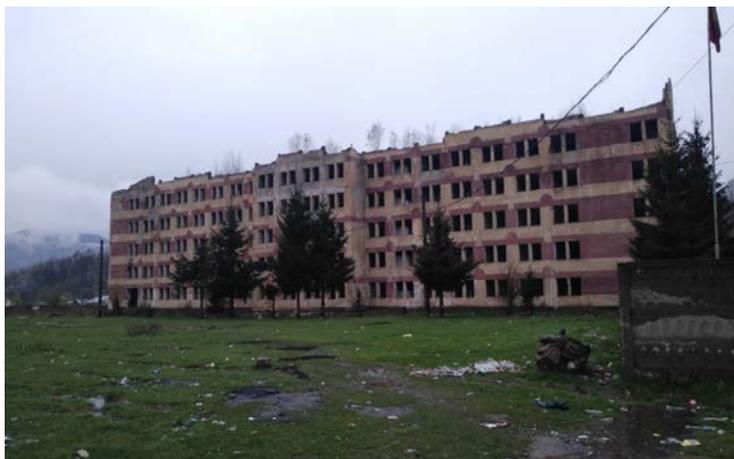
At the moment it is completely abandoned and like many other buildings it has been trampled by thieves of building materials.

However, being a newer building, with concrete structure, the resistance elements and the exterior walls are presented under acceptable conditions, which is why we consider that it could be used for another purposes (figure 7).

Fig. 7. *Former Gendarmerie*
