Research on the quality of welded joints of P265GH heat-resistant steel pipes at electron beam mechanized welding

This paper analyzes the quality of welded joints of high temperature resistant steel pipe at electron beam welding, knowing that the mechanical properties of these types of steels are influenced by the interaction of different processes specific to physical and mechanical metallurgy. Analyzing the values of the local hardening estimator ΔHV_{10} calculated between the characteristic areas of welded joints, it is observed that it has a decreasing tendency at thermally de-stressed joints, in all areas of the welded joints, especially in the welded seam.

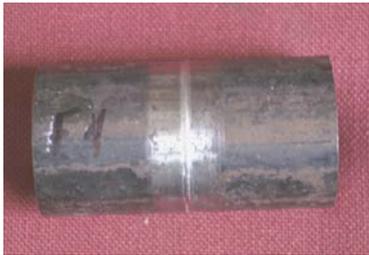
Figure 1. F1 butt welded sample, not heat treated.

The butt welded sample made of non-alloy heat-resistant steel type P265GH, Φ 60.3 x 6.0 mm (F1T) was subjected to a strain relief treatment according to Table 1. Figure 1 and Figure 2, show the visual aspects of the mechanized electron beam butt welded samples F1 and F1T. The joints did not show welding defects on the outer surfaces.

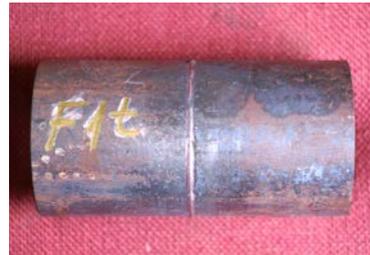
Figure 2. F1T butt welded sample, heat treated.

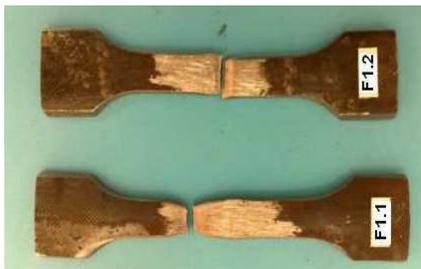
Figure 3. Broken test piece F1

a. The results of tensile tests on flat test pieces with calibrated area no. 1 and 2 taken from the mechanized welded buttocks with the F1 and F1T electron beam are centralized in Table 2. Figure 3 and Figure 4 show the specimens after the tensile tests.

Nr. sample	Nr. test	Test dimens. (S ₀ x B ₀), mm	F _{max} , N	R _m , N/mm ²	The place of rupture
F1	F1.1	5,9 x 12,1	34150	478	BM
	F1.2	5,9 x 12,0	32900	465	WELD
F1T	F1.1T	5,8 x 12,0	28600	411	WELD
	F1.2T	5,8 x 12,1	32300	460	WELD

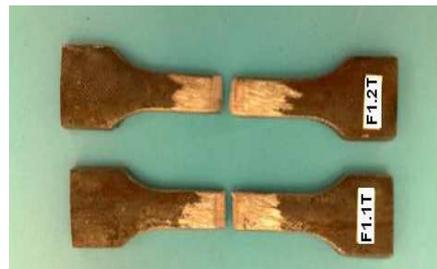
Figure 4. Broken test piece F1T

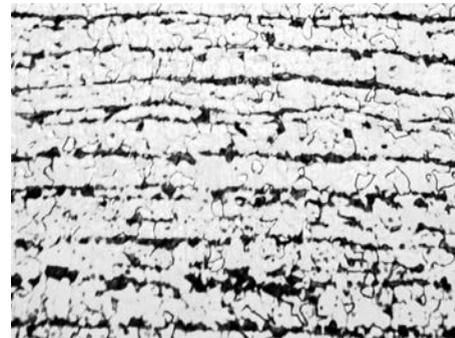
Figure 8. Sample FIT, BM, Nital 2%,
100X

c. The microscopic examination revealed specific microstructures, namely: in the base material (BM_{right} and BM_{left}), ferrite-pearlite granular structures in rows, with alternating ferrite and pearlite bands, whose granulation is between scores 7-8, according to SR ISO 643: 2003 (Figure 7 and Figure 8).

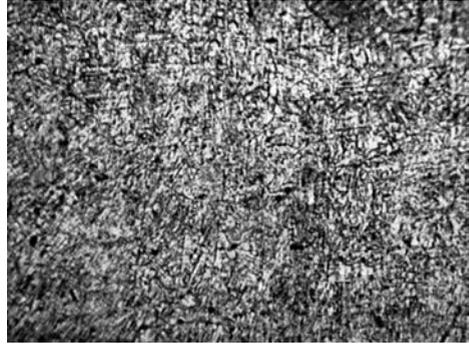
Figure 10. Sample F1T, WELD, Nital 2%, 100X

In the WELD), pearlite-ferrite structures with inferior bainite and acicular ferrite, according to SR ISO 643: 2003 (Figure 9 and Figure 10).

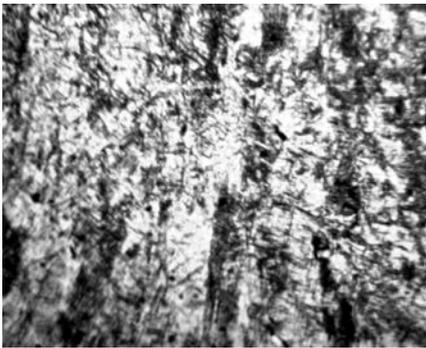
Figure 11. Sample F1, TIZ, Nital 2%, 100X

In thermally influenced areas (TIZ_{right} , TIZ_{left}), pearlite-ferrite granular structures with granulations point 4-5 and areas with acicular ferrite, according to SR ISO 643: 2003 (Figure 11 and Figure 12).

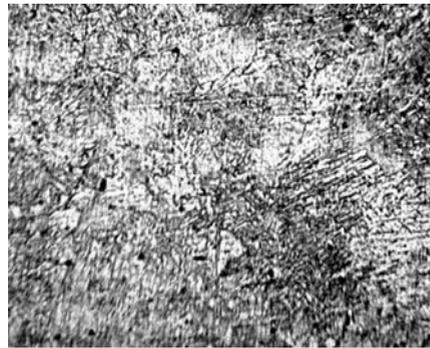
Figure 12. Sample F1T, TIZ, Nital 2%, 100X

The presence of acicular ferrite is greatly diminished in the heat-treated sample (Figure 12) attesting that the structural modification of the lower bainite is beneficial to the welding of non-alloy steel in reducing its hardness.
